DOWNTOWN TREE PLANTERS

Tree Planter Detail

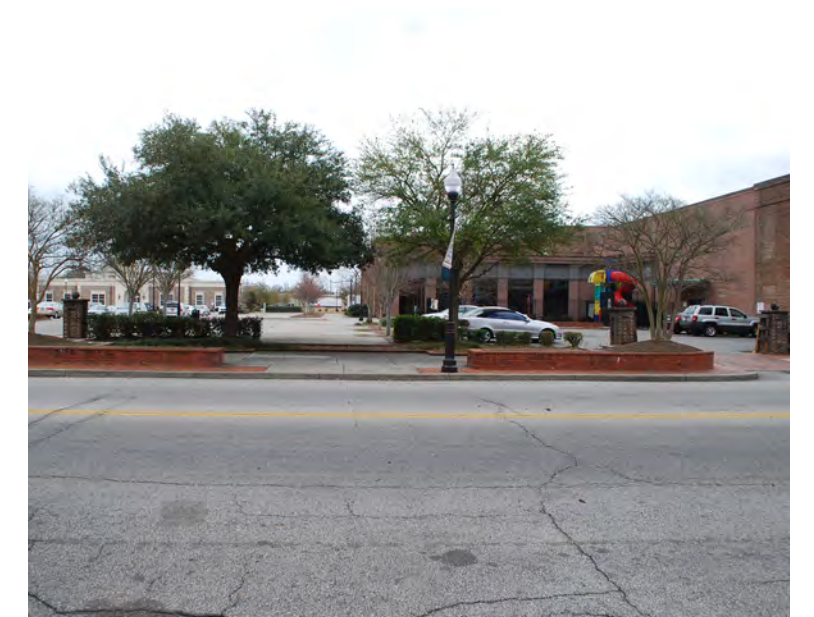
Existing Downtown

The existing live oak trees in the downtown streetscapes have matured to the extent that the root system has begun to buckle up portions of the existing raised brick planter curbings. With the understanding that this scenario is likely to continue at all planter areas, a modified planter design is recommended for all planters. Widening the planter areas parallel to the street curb and relative to the existing concrete score joints, and installing root barriers along with a new flush brick planter border will assist in alleviating some of the issues of the raised planter curbings. After consultation with a licensed arborist, some of the existing live oaks may need to be replaced, at which time an alternative tree species may be considered.
